Norges Rederiforbund Norwegian Shipowners' Association

"Sharing To Be Better"

Well Control Incident – 8 ¹/₂" section

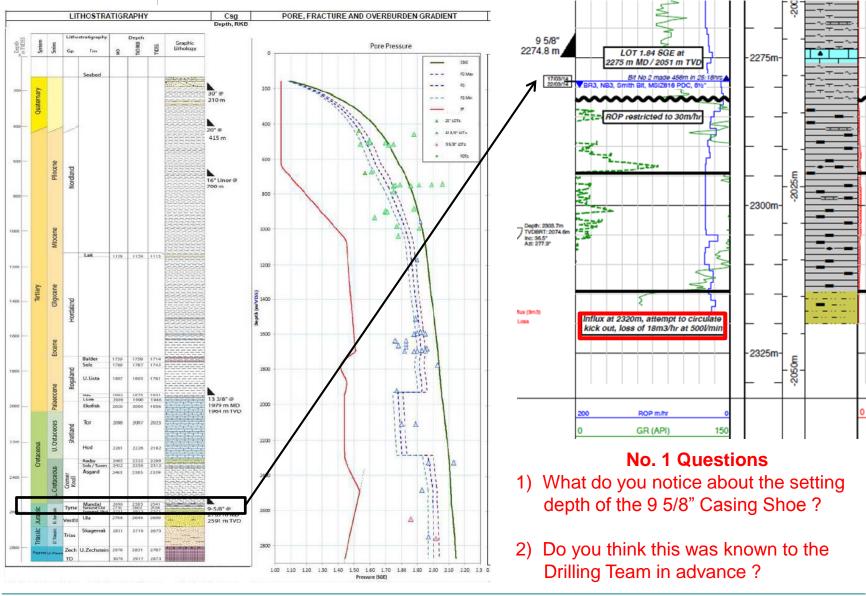
Well Schematic at Time of Incident

- 12 ¼" hole section was drilled with seepage losses throughout the section with 1.60 sg OBM.
- Hole angle c. 40 degs
- 9 5/8" casing was set and cemented at 2275 m.
- Casing shoe was set in a limestone stringer
- Casing was cemented with minor losses.

1) What do you notice about the setting depth of the 9 5/8" Casing Shoe ?

It should be observed that the shoe is set in a limestone stringer, which is not an ideal lithology to set a shoe in as it can fracture and induce losses in either the cementing operations or when drilling ahead

No it was not, the Team would never have planned to knowingly set a casing shoe in a limestone stringer for the reason above.

1) The original plan as noted in the drilling programme was for the 9 5/8" casing shoe to set in the claystone **below** this limestone stringer. The setting depth of the shoe was revised up to 2275 m for operational reasons relating to the latter P&A of the well. If this change of setting depth had been documented and risk assessed in a **Management of Change** document the casing shoe would not have been set at this depth which was coincidentally the depth of a limestone stringer.

2) Prior to running and cementing the 9 5/8" casing it was "know" to the Wellsite Geologist, Mud Logger and Ops Geologist that the shoe would be in the limestone stringer and they did not raise a "red flag" as they incorrectly assumed the Drilling Supervisor and the onshore Drilling Team were aware of this fact . **Never assume** that all members are fully aware of a given situation – always double check.
